Katherine and Mataranka mosquito survey report 12 to 14 February 2014

Nina Kurucz and Anna Debruyne
Medical Entomology
Centre for Disease Control
Department of Health
Northern Territory Government
December 2014

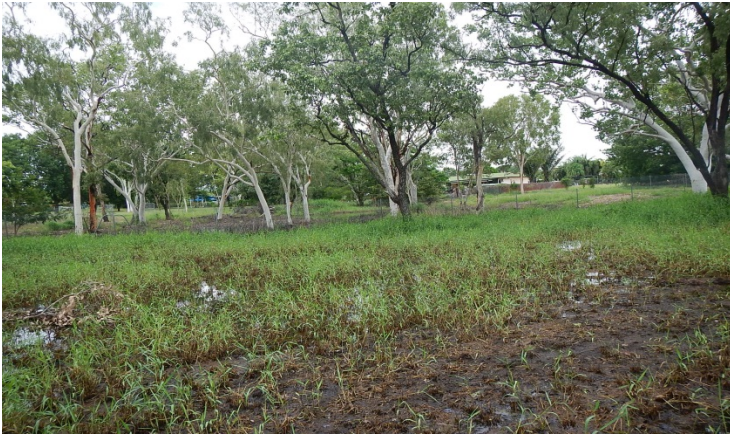
FIGURE 2:

The vacant Lot 3139 on the Victoria Highway, located adjacent to the Katherine Primary School on Riverbank Drive was the only site breeding relatively high numbers of *Culex annulirostris*, the principal vector for Ross River virus and Murray Valley encephalitis virus. The pest mosquito species, *Cx. quinquefasciatus* was also found in relatively high numbers. Breeding occurred in a number of small grassy depressions and wheel ruts throughout the site, and in a relatively large depression with extensive grass growth at the north-western end of the Lot, bordering the Primary School (Fig. 2).

Vacant Lot 3139 – Extensive depression with water ponding.
High number of *Cx. annulirostris* breeding.
Primary school with swamp area visible behind fence.

out by ME on Lot 3139, using s-methoprene pellets, with s-methoprene briquettes placed in the actual swamp.

Both the swamp area and Lot 3139 will be re-assessed by ME in 2015, with rectification measures and mosquito control to be discussed with the relevant land owners.

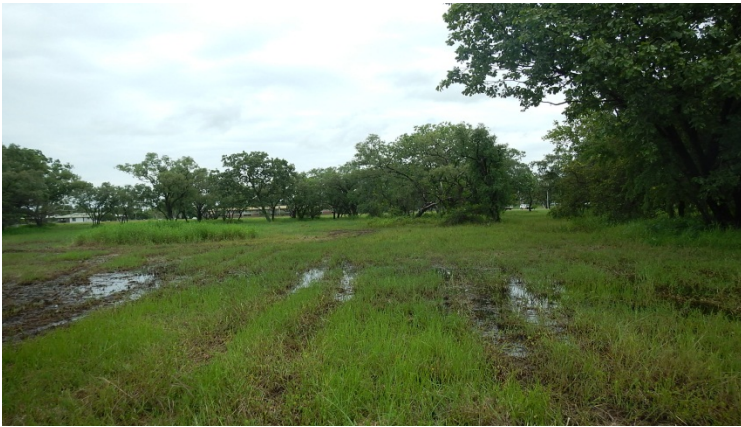
Vacant Lot 3139 – wheel ruts with water ponding.
High number of *Cx. annulirostris* breeding.

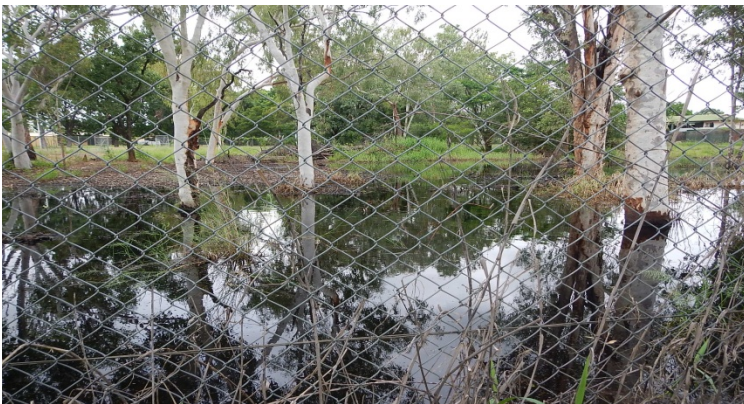
Water from the large depression located on Lot 3139 accumulated in a swamp located at the north-east corner of the school premise (Fig. 2). Although the swamp area was not breeding mosquitoes at the time the survey was carried out, it was assessed as a potential mosquito breeding site. Mosquito larval control was carried

Primary school – fence separating the swamp area on the school premise and vacant Lot 3139.
Deep water ponding at fence line.
